BUSH BP70

ELECTRICAL AND RADIO TRADING SERVICE CHART

MARCONIPHONE 283 COLUMBIA 1005

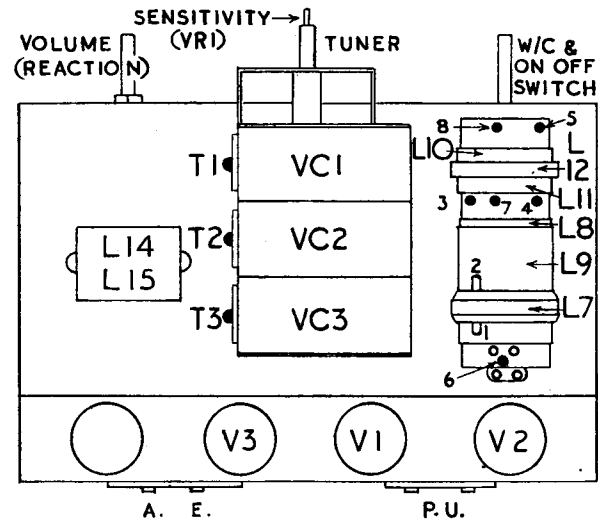
Above, the cabinet of the old but popular Marconi 283 is still familiar. Released in 1933, it is a three-valve type for battery operation and using a moving-coil speaker. Left, the top-deck layout showing gang, coils and valves.

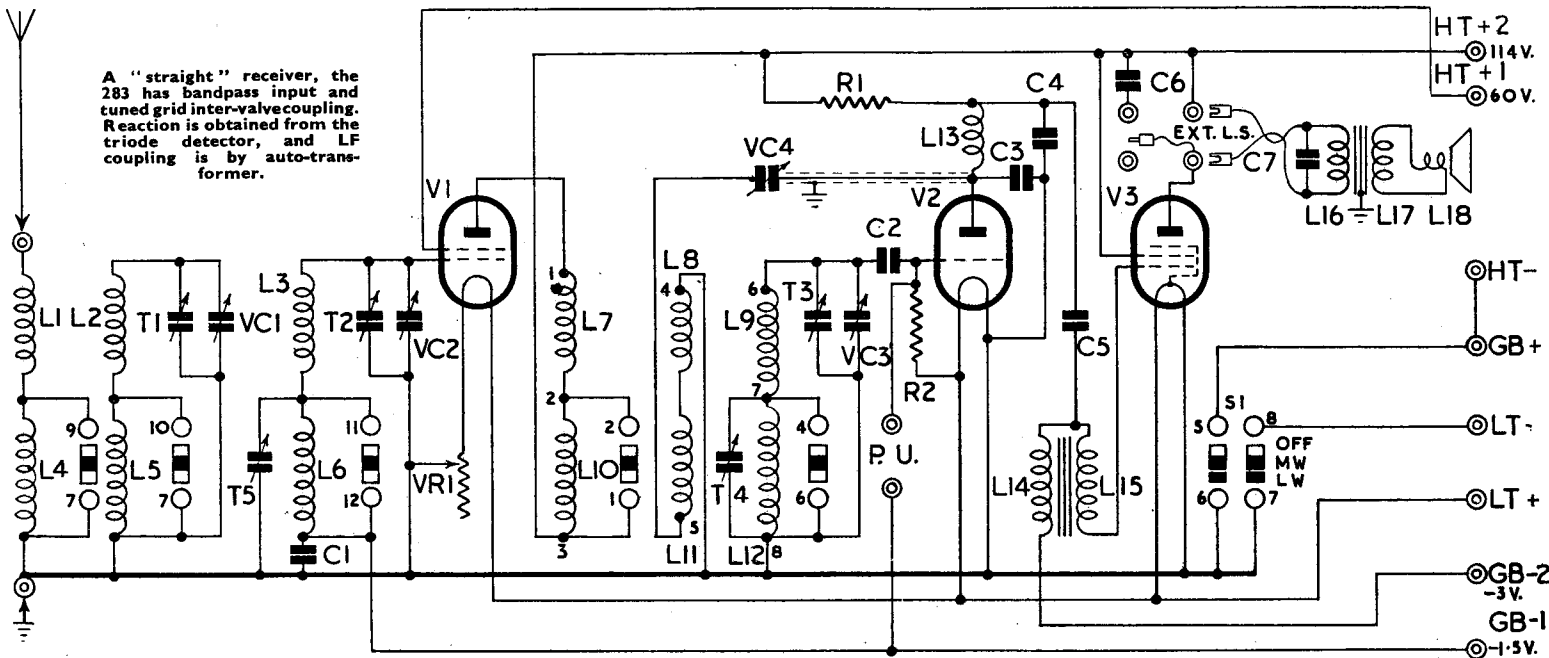
A "straight" receiver, the 283 has bandpass input and tuned grid inter-valvecoupling. Reaction is obtained from the triode detector, and LF coupling is by auto-transformer.

COUPLING coils L1 (MW), L4 (LW) transfer the signals to the primary windings L2, L5 of a coupling transformer in which L3, L6 are the secondaries. Primary and secondary windings are tuned and signals are fed to the grid of the screened grid HF amplifier V1.

L10 (LW) with tuned secondaries L9 and L12. Reaction windings L8 and L11 are coupled to the transformer and fed from the anode of the detector valve V2 by means of the HF choke L13 and reaction condenser (volume control) VC4.

Anode HF filtering is effected by C3 and a certain amount of LF correction by C4. LF signals are resistance capacity coupled by R1 and C5 to the intervalve transformer L14, L15. Bias of about three volts negative is applied via the windings to the grid of the pentode output valve V3.
